SITUACIÓN DEFICIENCIAS DETERMINADAS PREVIO ☒ DURANTE ☐ POSTERIOR ☐

| NOMBRE DEL ESTABLECIMIENTO: | INEB DE TELESECUNDARIA | DIRECCIÓN DEL ESTABLECIMIENTO: | CASERÍO CRUCE PERDIDO |
| CÓDIGO DEL ESTABLECIMIENTO: | 17-04-2725-45 | FECHA: | 10/9/2025 |

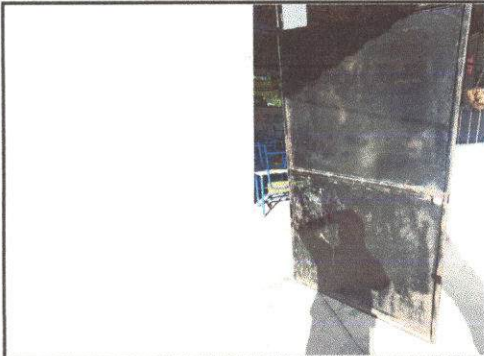
Foto 1: Mantenimiento a estructura (lijado, cambio de tubo, cepillado, sujeciones, aplicación de pintura)

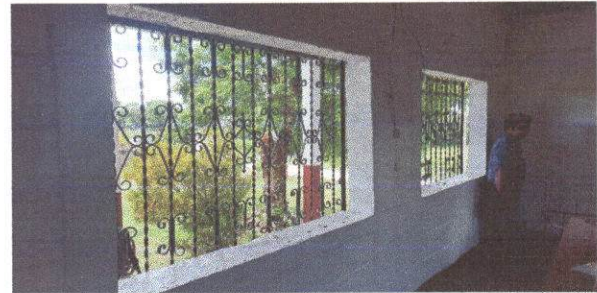
Foto 2: Fabricación e instalación de marcos de aluminio mil finish

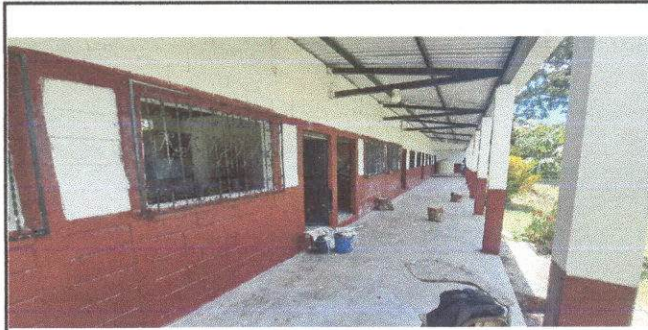
Foto 3: Mantenimiento a balcones de metal

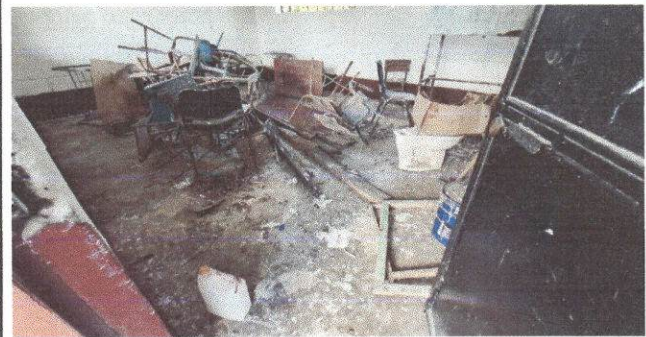
Foto 4: Instalación de piso cerámico

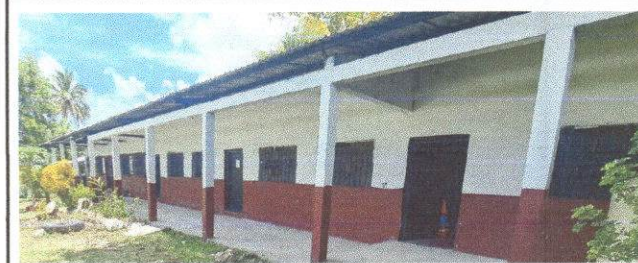
Foto 5: Pintura en muros exteriores e interiores

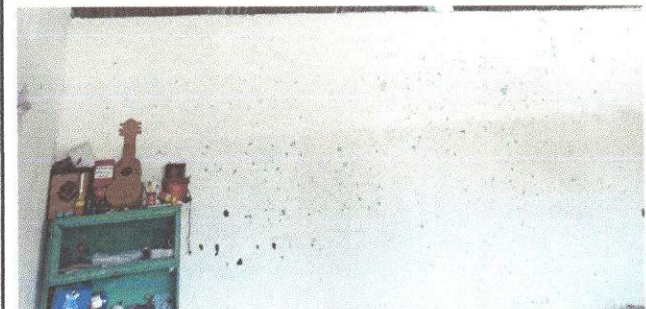
Foto 6: Reparación de muro perimetral de block

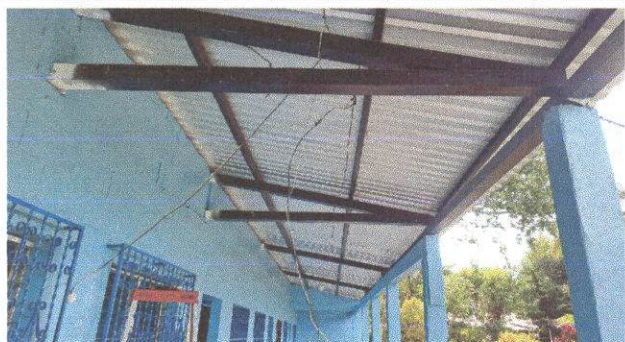
Foto 7: Sustrución de ducto elétrico + accesorios

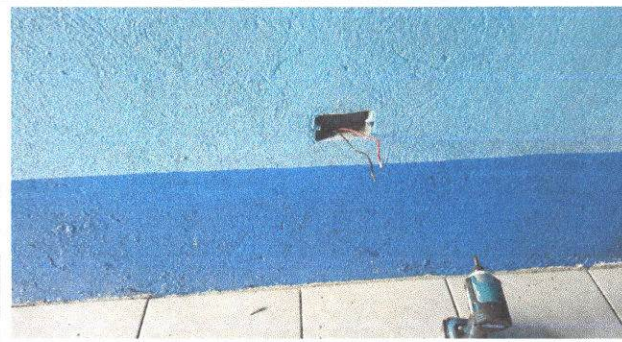
Foto 8: Sustrución de tomacorrientes Dobles
